Case Study

Creative Inspection for Water Ingress in Composite Aircraft Material

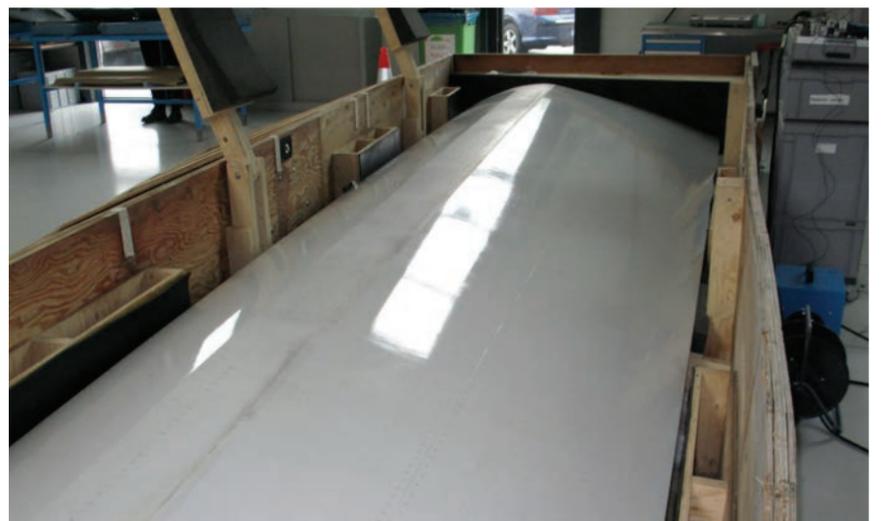
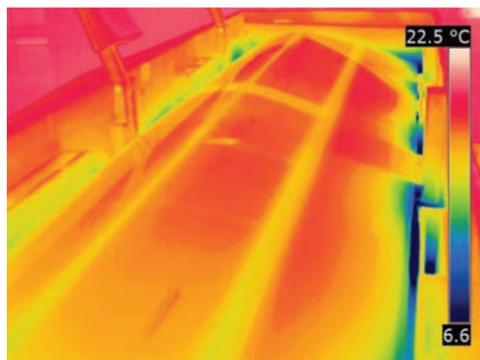
Overview of the upper skin of the outboard flap: the thermal picture reveals no water ingress. The blue colour indicates the presence of dry ice in the wooden case and the airflow from the freezer unit.

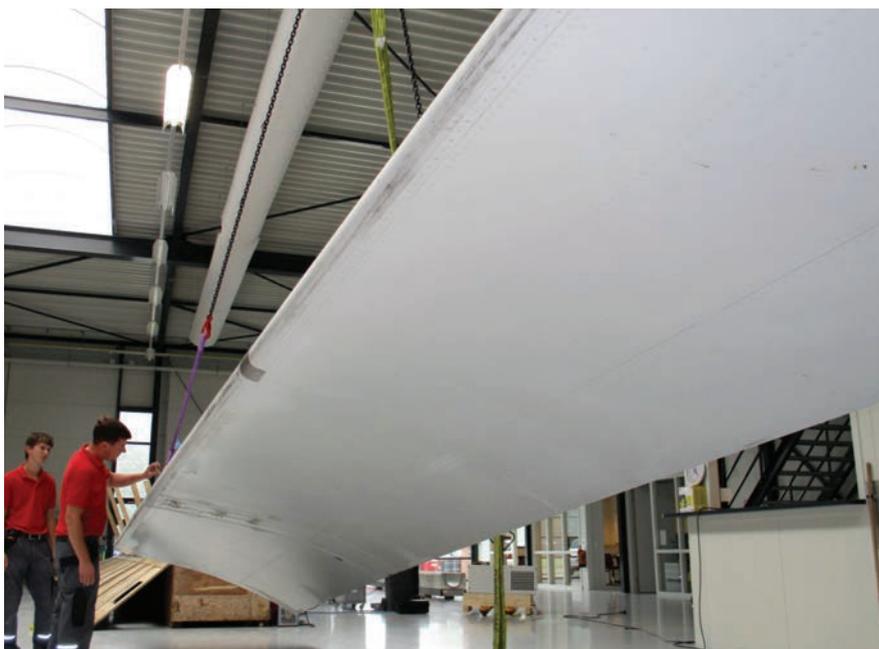
Overview of the lower skin of the outboard flap: the thermal picture reveals no water ingress. The blue colour indicates the airflow from the freezer unit.

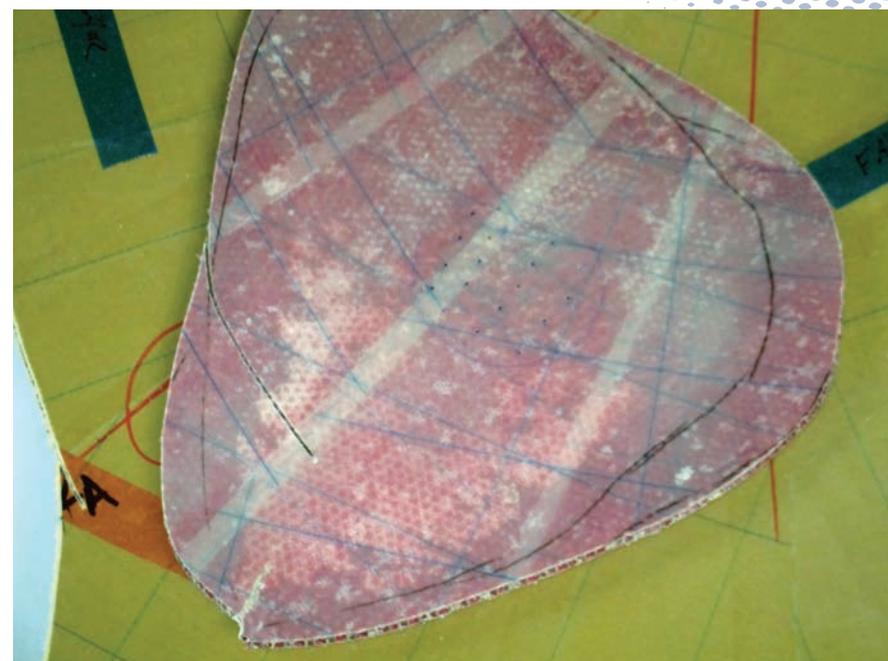
A composite test specimen was injected with water: this is clearly visible on the thermal image.

“We wanted to confirm for ourselves and for the customer that this methodology works,” said Ralf Grispen. “Therefore, we prepared a small test specimen, made from the same composite material as the Boeing flap, which we deliberately injected with water. This would serve as our reference.”

The thermal inspection was done successfully with a FLIR P660 thermal imaging camera. And although no moisture or water was found on the composite parts of the flap, the thermal image of the reference specimen clearly showed the presence of water.
